**POTABLE WATER
STORAGE FACILITIES
INSPECTIONS AND
ASSESSMENTS**

**NAVAL AMPHIBIOUS BASE
LITTLE CREEK
NORFOLK, VIRGINIA**

FPO-1-84(41) OCTOBER 1984

19. ABSTRACT (Continue on reverse if necessary & identify by block number)
In October of 1984, an underwater inspection was conducted at the Naval
Amphibious Base, Little Creek, Norfolk, Virginia to assess the condition of
seven potable water storage facilities.

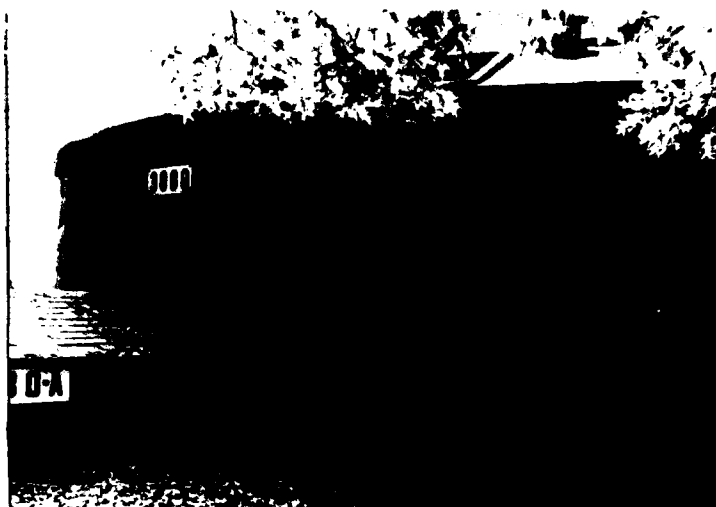
On the exterior of the reservoir there are horizontal, hairline cracks on the walls all around the facility, and a few vertical hairline cracks. There is efflorescence due to leaching along these cracks and the cracks vary in length from approximately 5 to 20 feet. Refer to Photographs 4.4-1 and 4.4-7 for typical views of these cracks. There are also minor random hairline cracks on the top of the roof slab as shown in Photograph 4.4-8. Inspection notes are included on Figure 4.4.

PHOTOGRAPH 4.4-1
General View of Facility 3080.
